Flood Control Project Maintenance
Levee Inspections

Fall 2013 Levee Maintenance Deficiency Summary Report

Sacramento River Basin

| RD0999 Reclamation District No. 0999 Netherlands | Overall LMA Rating | Total LMA Miles | | | | | | | |

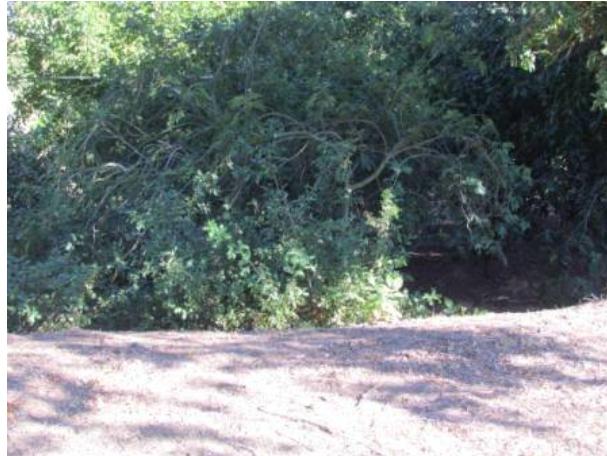
| richard_f_20130918_377.jpg | |

| Looking west at dense trees on landside slope.(Spring 2011) | |

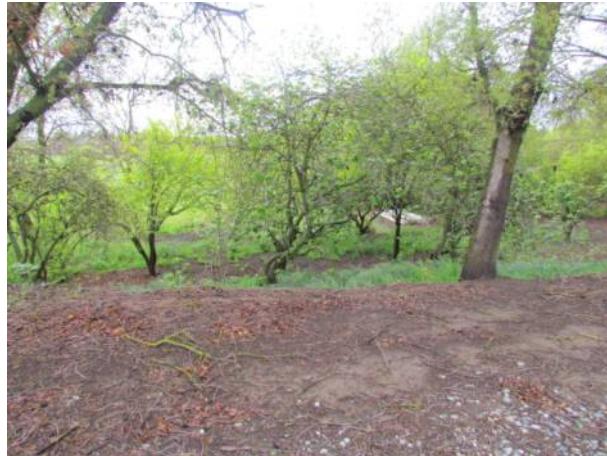
| richard_f_20130918_378.jpg | |

| Looking west at trimmed trees on landside slope.(Spring 2012) | |

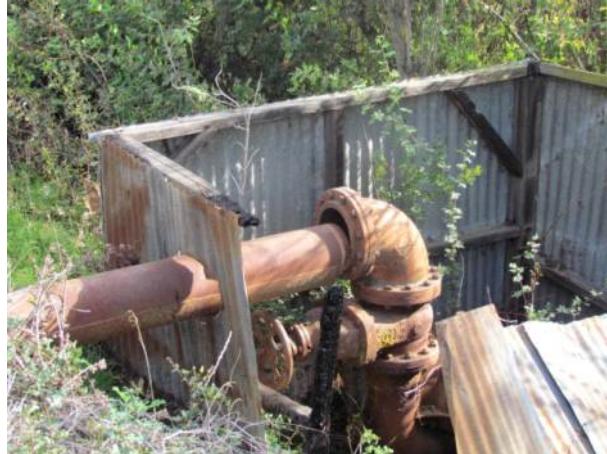
| richard_f_20130918_385.JPG | |

| Looking east at pipe disconnected from pump. | |

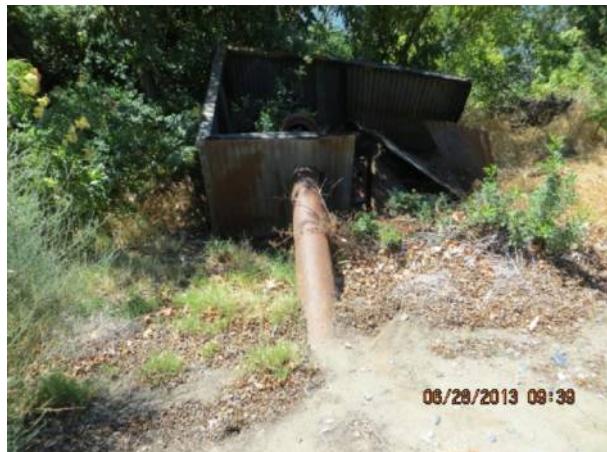
| UCIP_8179.jpg | |

| Abandoned pumphouse on WS slope. | |

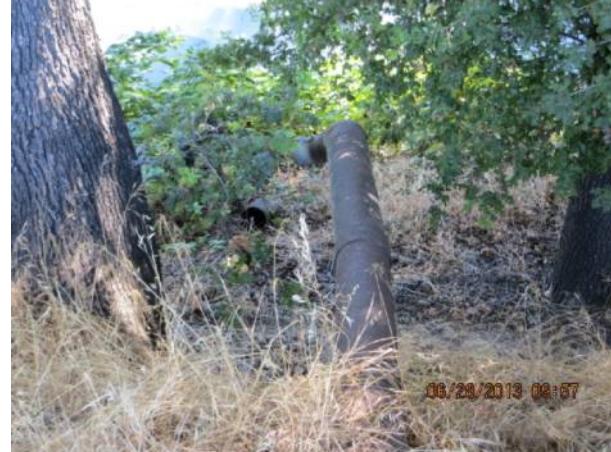
| UCIP_8192.jpg | |

| Pipe open on WS slope. | |

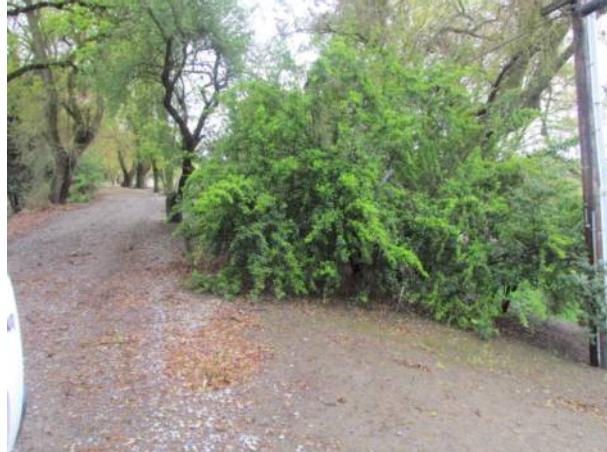
| richard_f_20130918_396.jpg | |

| Looking southwest at untrimmed tree on waterside shoulder and slope. | |

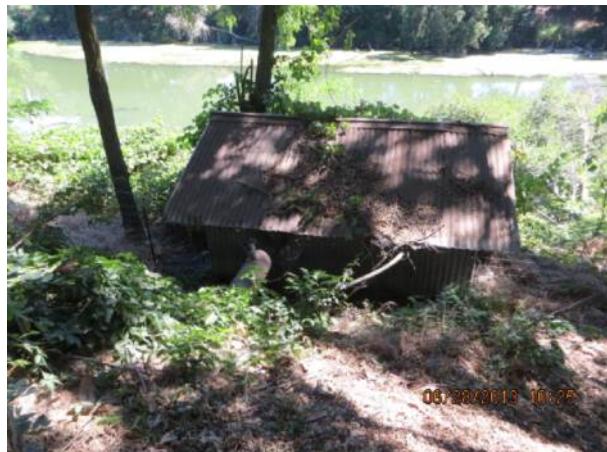
| UCIP_8184.jpg | |

| Corrugated metal pumphouse on WS slope. | |

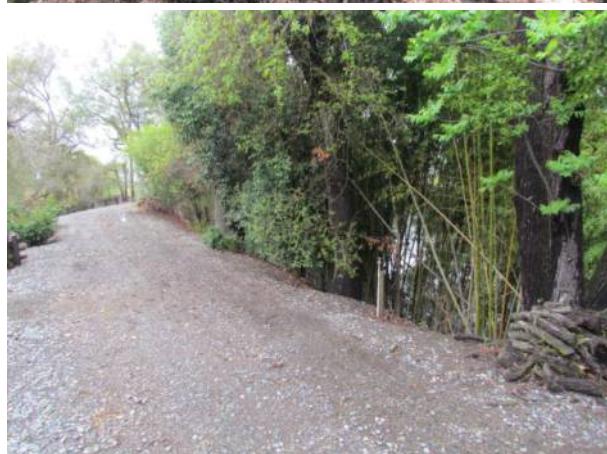
| richard_f_20130918_397.jpg | |

| Looking northeast at dense vegetation on waterside slope. | |

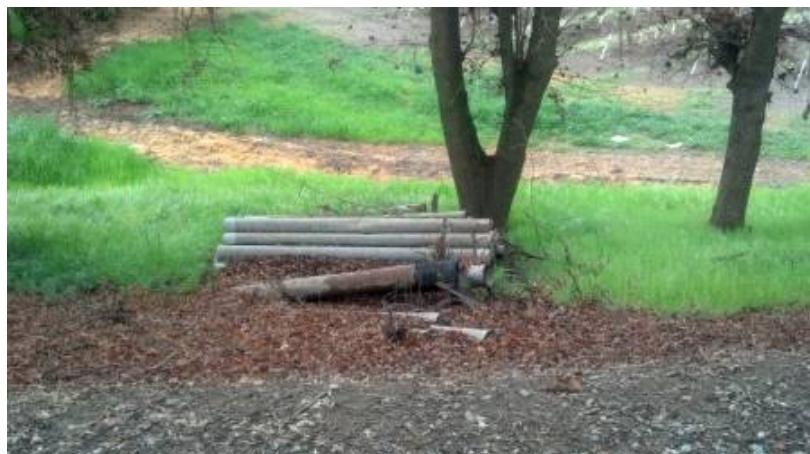
| richard_f_20130918_430.jpg | |

| Looking west at irrigation pipes on landside toe. | |

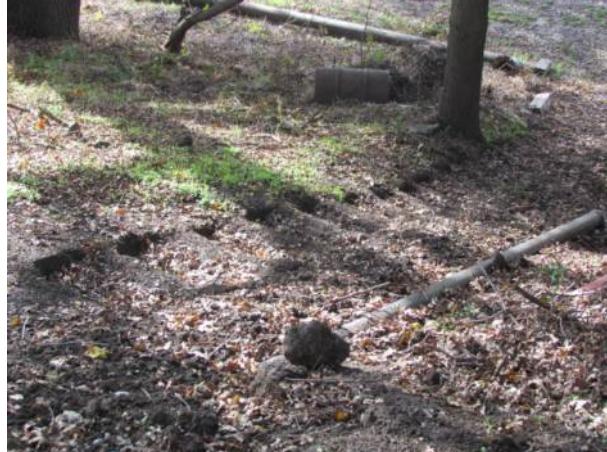
richard_f_20130918_402.JPG

Looking east at excavated stairs on landside slope

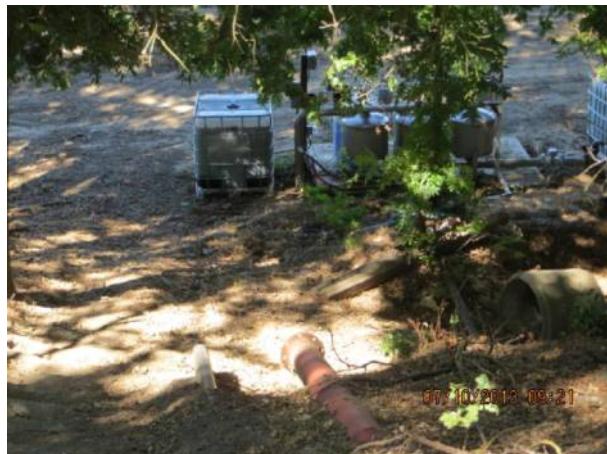
UCIP_9088.jpg

Pipe visible on LS slope with filter plant in background.

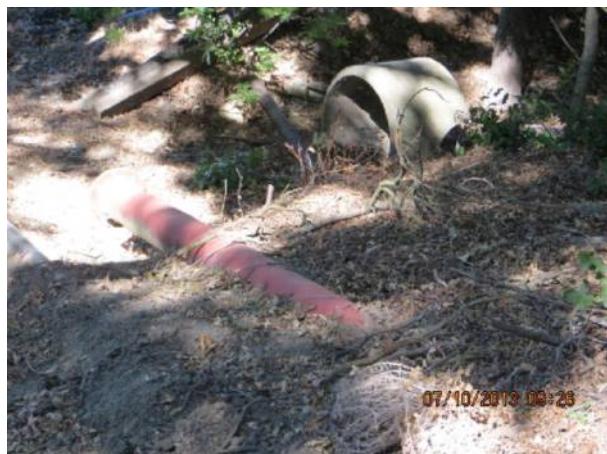
UCIP_8405.jpg

6-inch steel pipe on LS slope with evidence of 36-inch standpipe in background.

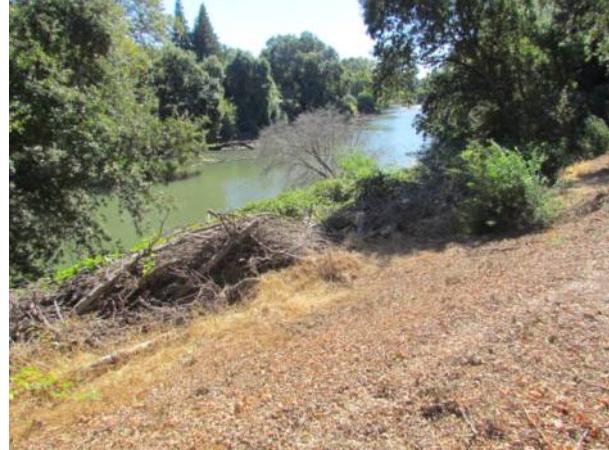
| richard_f_20130927_497.JPG | |

| Looking southeast at prunings on waterward slope. | |

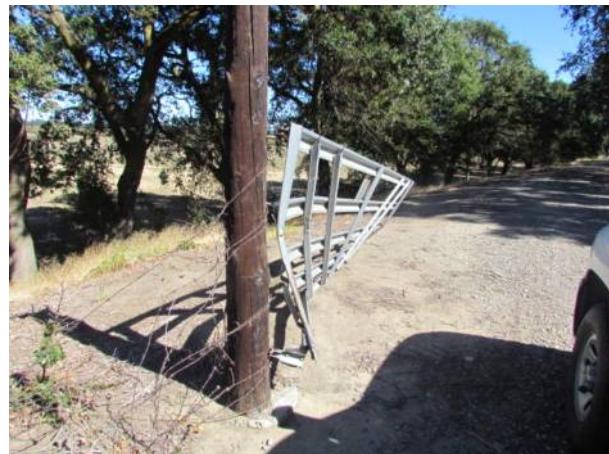
| richard_f_20130927_498.JPG | |

| Looking northwest at damaged gate on levee crown. | |

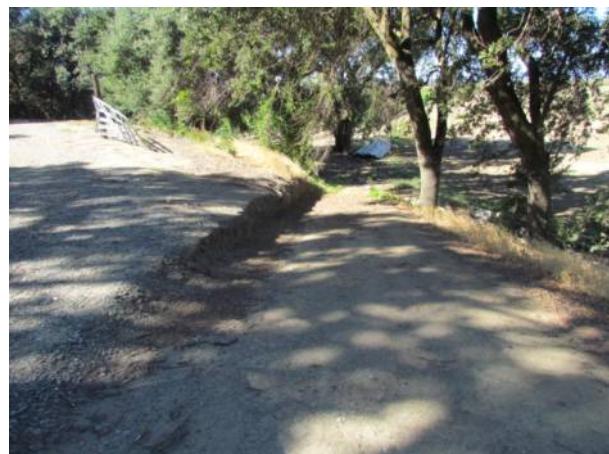
| richard_f_20130927_499.JPG | |

| Looking southwest at ramp on landward slope. | |

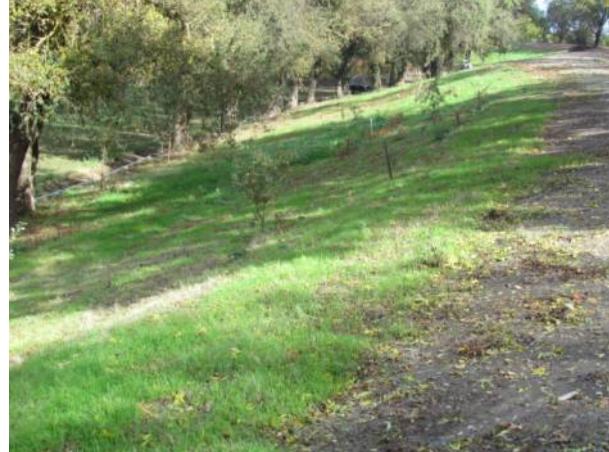
| richard_f_20130918_418.JPG | |

| Looking northwest at newly planted trees on landside slope. | |

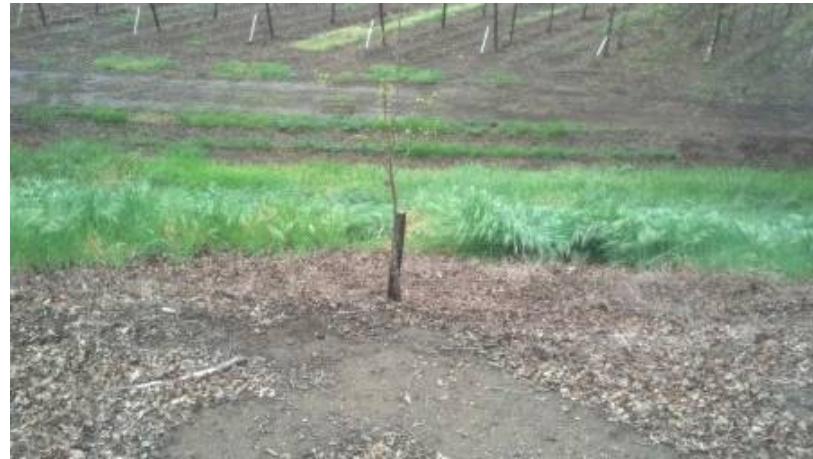
| richard_f_20130918_419.jpg | |

| Looking west at newly planted tree on landside slope. | |

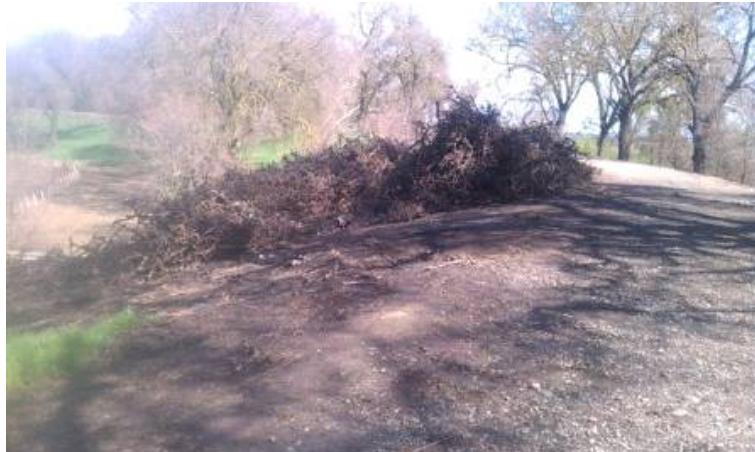
| richard_f_20130918_403.jpg | |

| Looking northwest at pruning pile on landside slope. (Spring 2011) | |

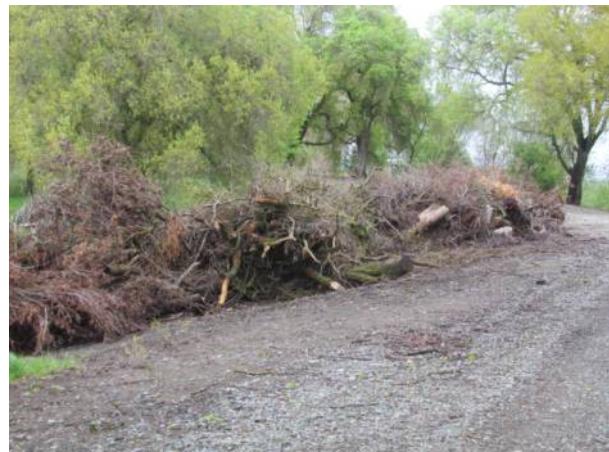
| richard_f_20130918_404.jpg | |

| Looking northwest at prunings on landside slope. (Spring 2012) | |

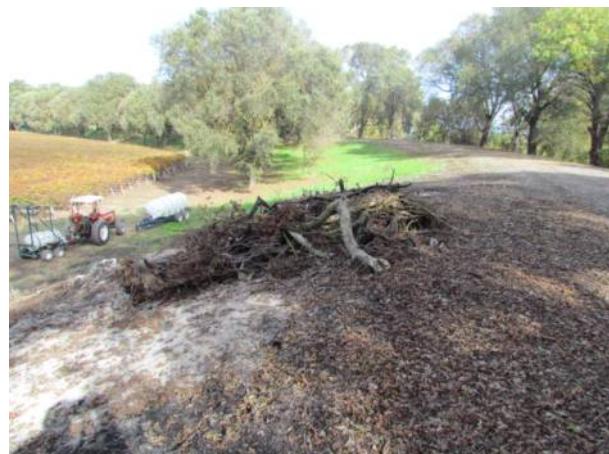
| richard_f_20130918_405.JPG | |

| Looking northeast at prunings on landside slope. | |

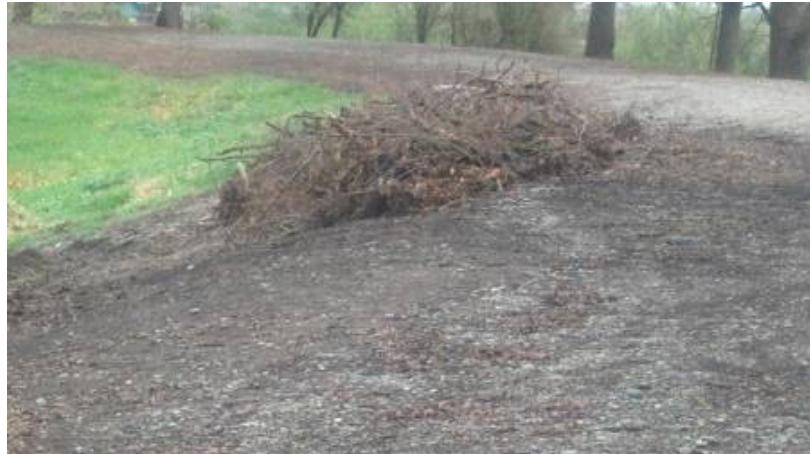
| richard_f_20130918_406.jpg | |

| Looking northwest at prunings on landside slope. Spring 2013 | |

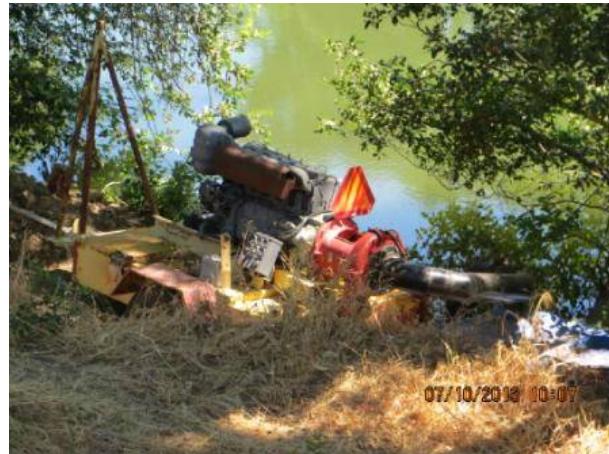
| UCIP_9082.jpg | |

| Portable pump on WS toe. | |

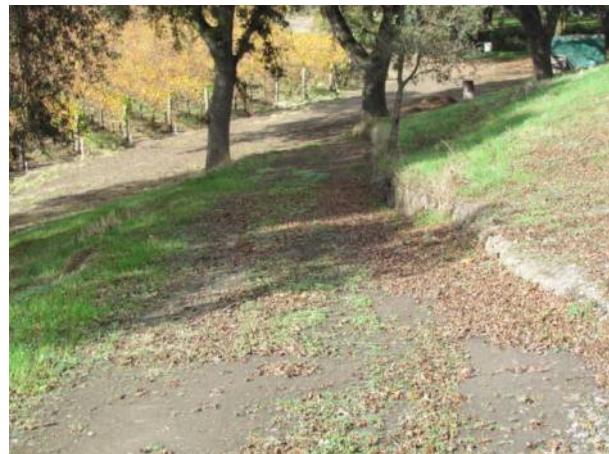
| richard_f_20130918_427.JPG | |

| Looking east at unauthorized ramp on landside slope. | |

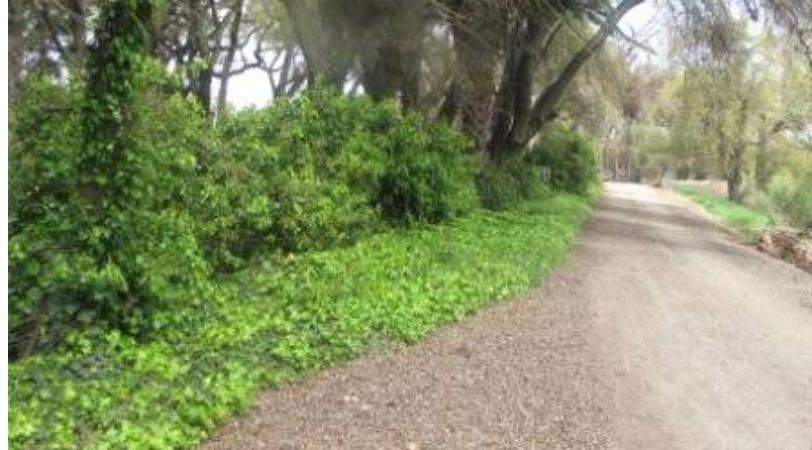
| richard_f_20130918_407.jpg | |

| Looking north at overgrown landscape on landside slope and toe. | |

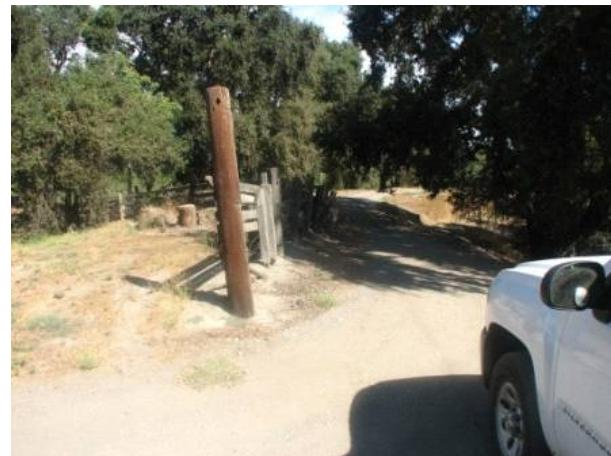
| richard_f_20130918_414.jpg | |

| Fence, firewood and material at landside shoulder. | |

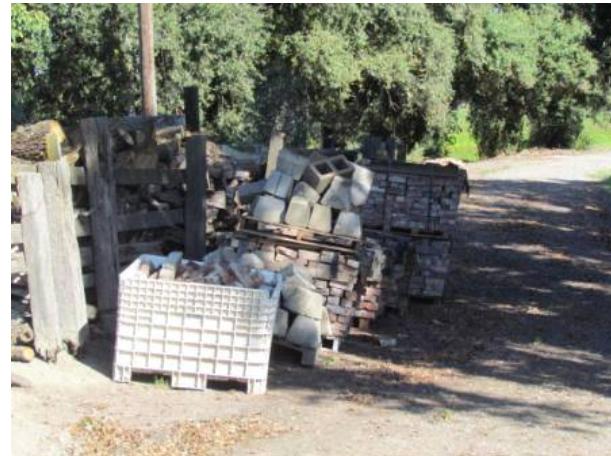
| richard_f_20130918_415.jpg | |

| Looking north at firewood and other material on landside shoulder and crown. | |

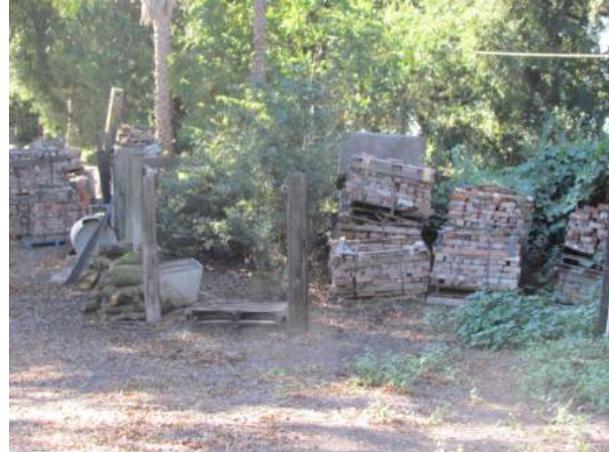
| richard_f_20130918_416.jpg | |

| Looking south at firewood and other material on landside shoulder and crown. | |

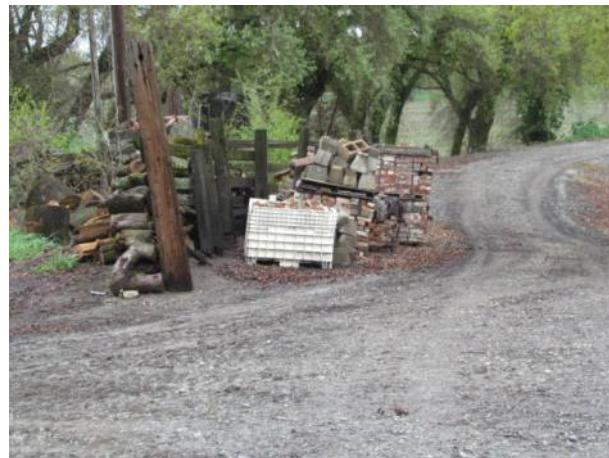
| richard_f_20130918_417.jpg | |

| Looking northeast at firewood and other material on landside shoulder. (Spring 2012) | |

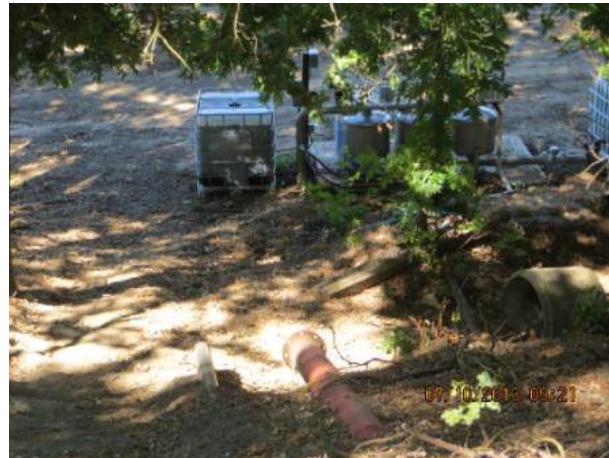
| UCIP_9084.jpg | |

| Pipe visible on LS slope with filter plant in background. | |

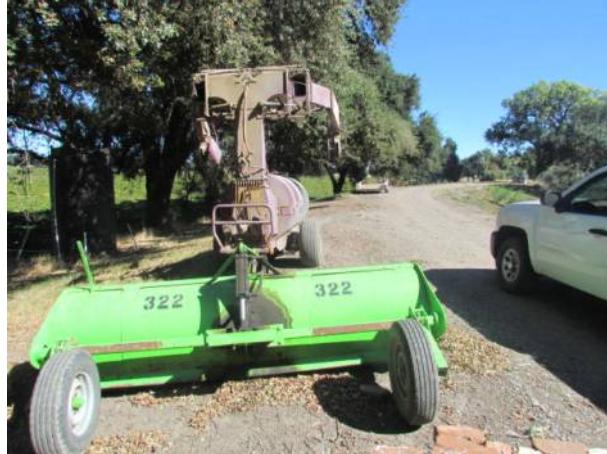
| richard_f_20130927_500.JPG | |

| Looking north at farm equipment on landward shoulder. | |

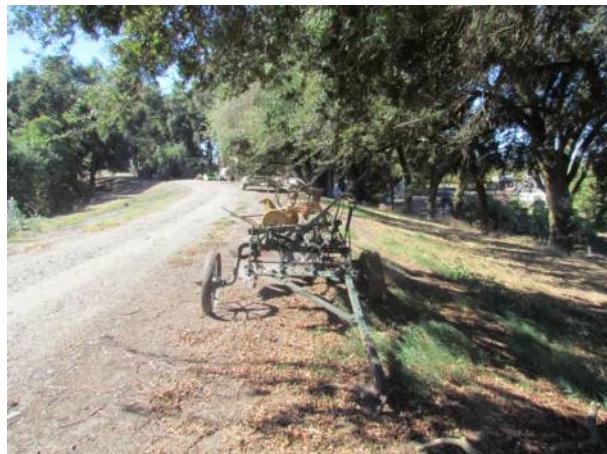
| richard_f_20130927_501.JPG | |

| Looking south at farm equipment on landward shoulder. | |

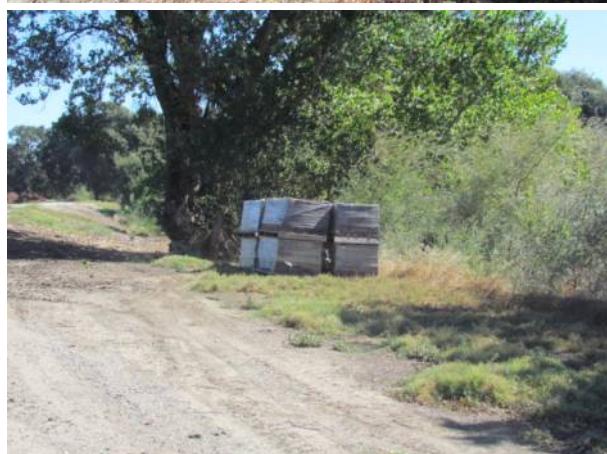
| richard_f_20130927_502.JPG | |

| Looking northeast at pallets of bricks store on waterward shoulder. | |

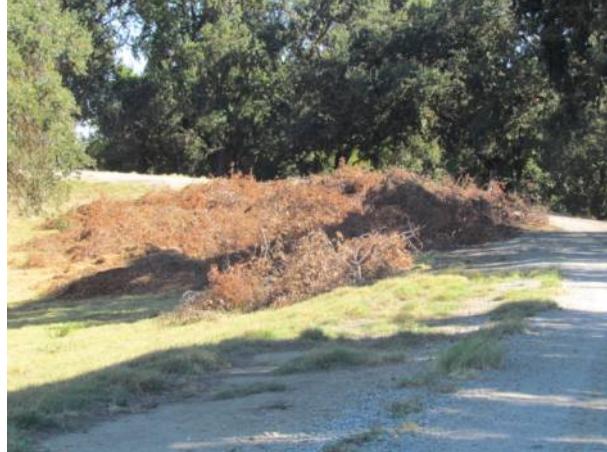
| richard_f_20130927_503.JPG | |

| Looking northeast at large prunings on landward slope. | |

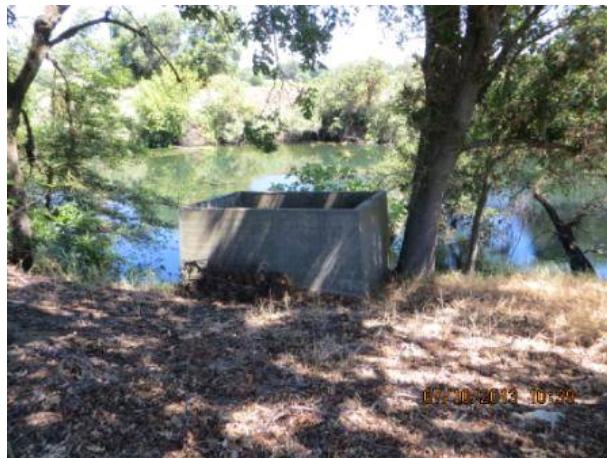
| UCIP_8479.jpg | |

| Concrete pump pit on WS toe. | |

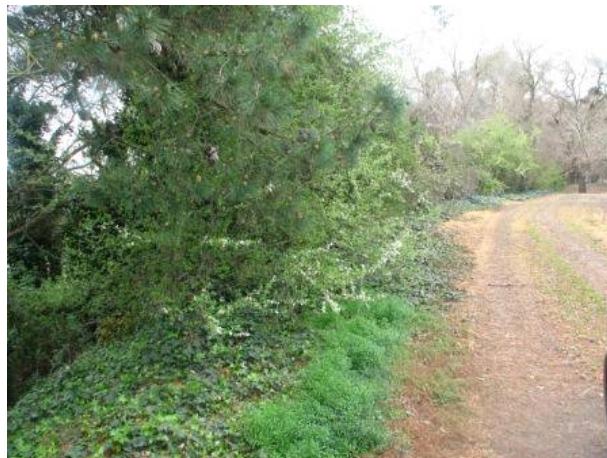
| richard_f_20130918_394.JPG | |

| Landscaping on landside slope blocking view of slope from LM 7.65 to 7.72 | |

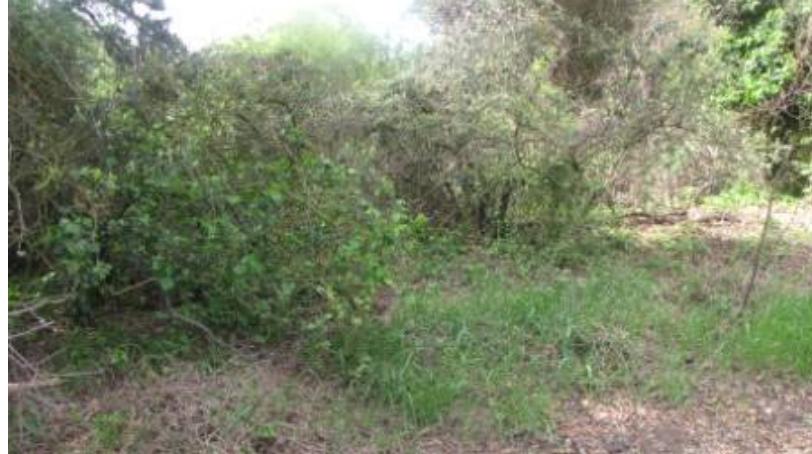
| richard_f_20130918_395.jpg | |

| Looking east at overgrown landscape on landside slope. | |

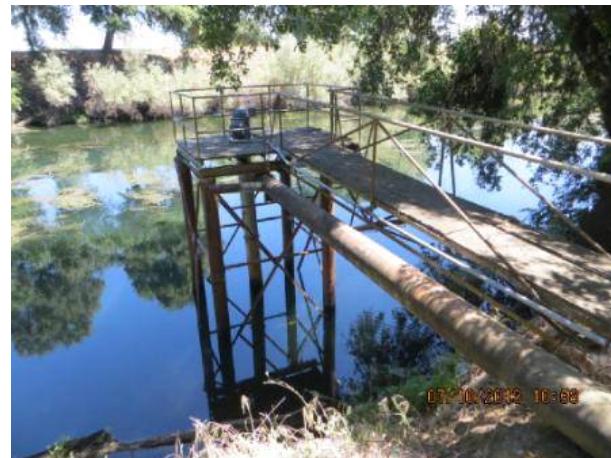
| UCIP_8505.jpg | |

| Waterway | | | | | | | Bank | Unit Miles | Inspection Start/End | Inspector | | |
|---|---|---|---|---|---|---|--|---|---|---|---|---|
| 151 | 8.17 | 8.17 | Supplemental DWR UCIP Field Study | WS M | En | Inspector Comments: FS_ID:15683 EP_NO: 13463 Repair Type: Non-Urgent Crossing Status: Found UCIP Comments: Pipe exposed in excavation on LS shoulder at what may be a leak. FIELD_STRUCT_DESC: 12-inch pipe through the levee 2.5-feet below the crown. Pump on pile structure with walkway on WS toe. 12-inch PVC standpipe on LS toe next to filter plant and shed. (Permit No. 13463, 1982). 1.5-inch PVC electrical conduit at same location. This pipe replaced an existing 8-inch pipe that was grouted in place. FS Date: 07/10/2013 | 38.409421 ° | 38.409421 ° | 189 | -121.541007 ° | -121.541007 ° | |

| Pump on metal pier with walkway at WS toe | |

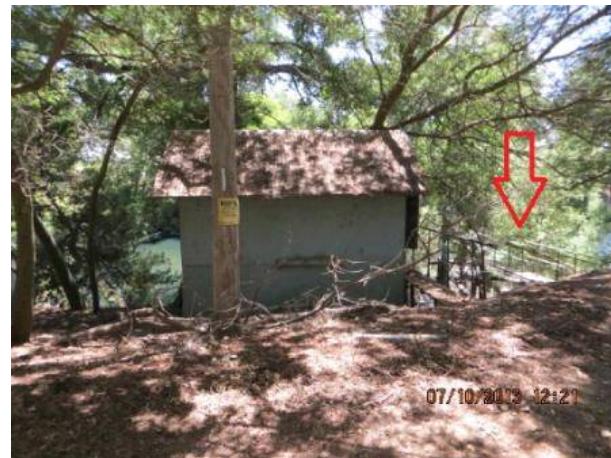
| UCIP_8599.jpg | |

| Pump on metal pier with walkway on WS slope. | |

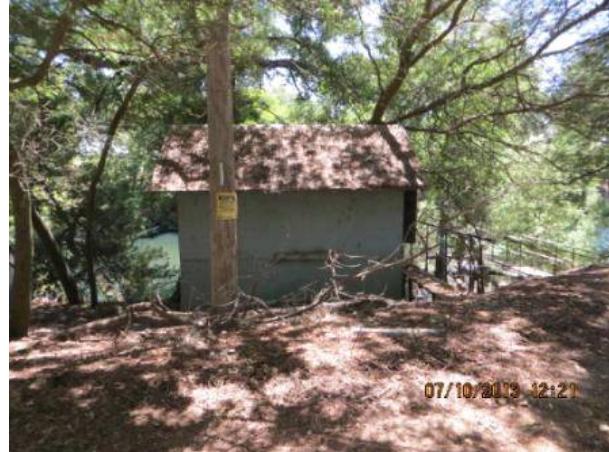
| UCIP_8590.jpg | |

| Concrete pumphouse on WS slope. | |

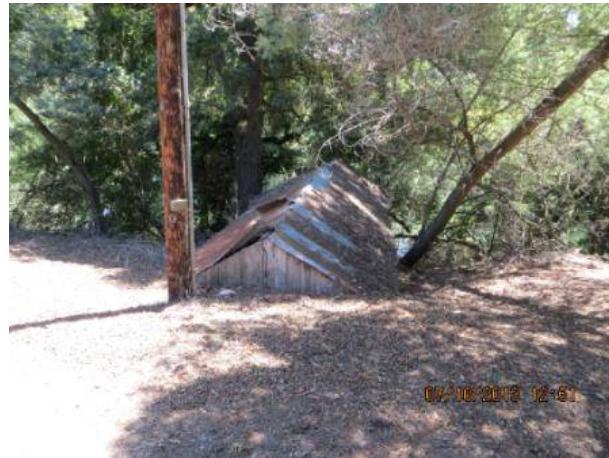
| UCIP_8603.jpg | |

| Waterway | | | | | | | Bank | Unit Miles | Inspection Start/End | Inspector | |
|---|---|---|---|---|---|---|--|---|---|---|---|
| 156 | 8.23 | 8.23 | Supplemental DWR UCIP Field Study | WS M | En | | Inspector Comments: FS_ID:15685 EP_NO: 4851 Repair Type: Non-Urgent Crossing Status: Found UCIP Comments: Pipe appears to be abandoned and should be done so properly. FIELD_STRUCT_DESC: 8-inch pipe through levee 6.2 feet below crown. Gate valve in pump house on the waterward slope, service pole on both slopes (Permit No 4851, 1965). Originally included in the 1966 O&M manual. FS Date: 07/10/2013 | 38.409749 ° | 38.409749 ° | 192 -121.540079 ° | -121.540079 ° Y |

| Pumphouse/concrete headwall on WS slope. | |

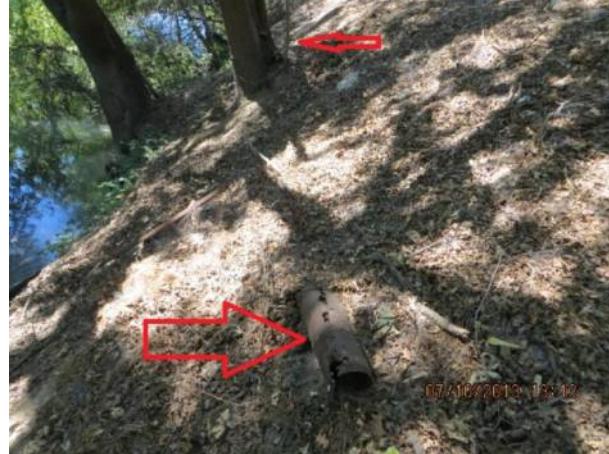
| UCIP_8606.jpg | |

| 8-inch pipe debris with 1.5-inch electrical conduit visible in background on WS slope. | |

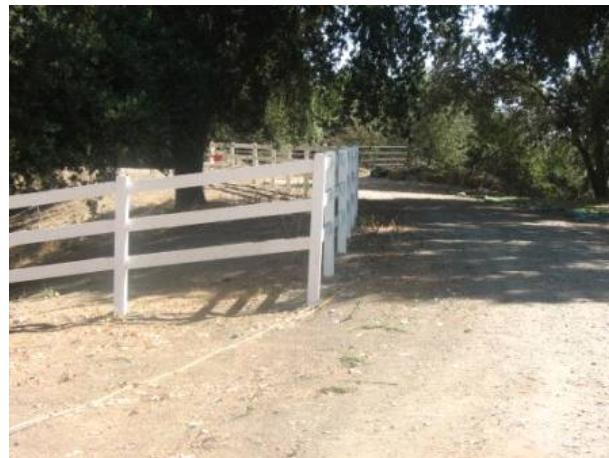
| richard_f_20130918_420.jpg | |

| New installed unauthorized fence at landside slope and shoulder. | |

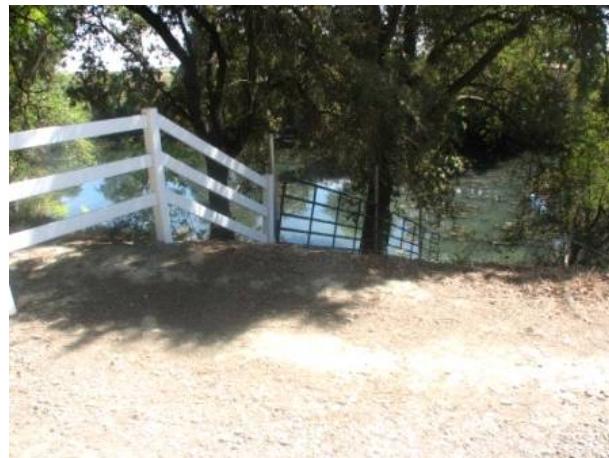
| richard_f_20130918_421.jpg | |

| New unauthorized fence that extend from landside toe to waterside toe. | |

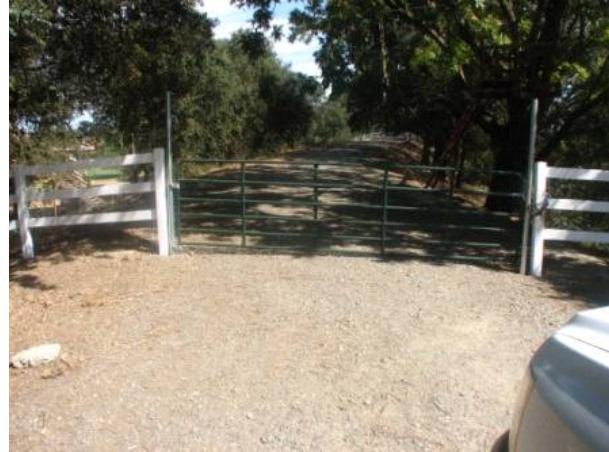
| richard_f_20130918_422.jpg | |

| View of fence & gate across levee crown, landside & waterside slope. | |

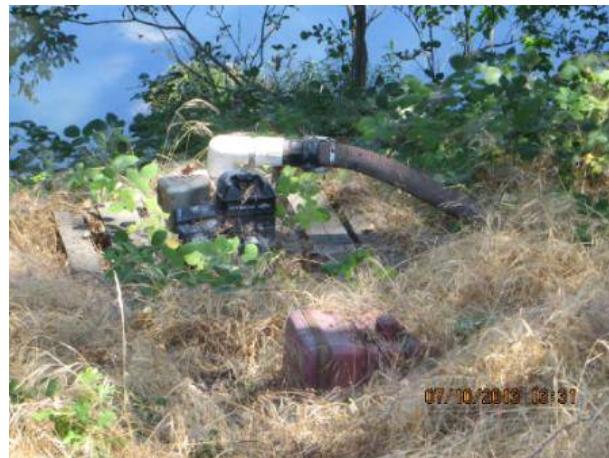
| UCIP_9093.jpg | |

| Waterway | | | | | | | | Bank | Unit Miles | Inspection Start/End | Inspector |
|---|---|---|---|---|---|---|--|---|---|---|---|
| 176 | 8.77 | 8.77 | Supplemental Field Study | DWR UCIP | LS En | M | Inspector Comments: FS_ID:16345 EP_NO: N/A Repair Type: Non-Urgent Crossing Status: Found UCIP Comments: Need to determine permit No for crossing or remove it. FIELD_STRUCT_DESC: 3-inch plastic irrigation hose over the levee. Small portable pump on WS toe. FS Date: 07/10/2013 | 38.410531 ° | 38.410531 ° | 195 | |

| Portable pump on WS toe. | |

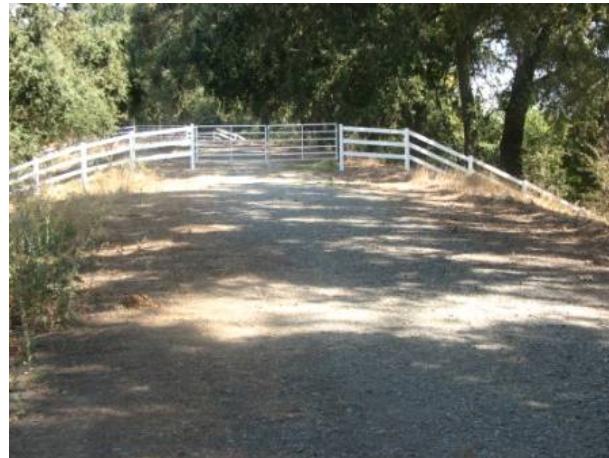
| richard_f_20130918_423.jpg | |

| New unauthorized fence and gate that extends from landside toe across levee crown to waterside toe. | |

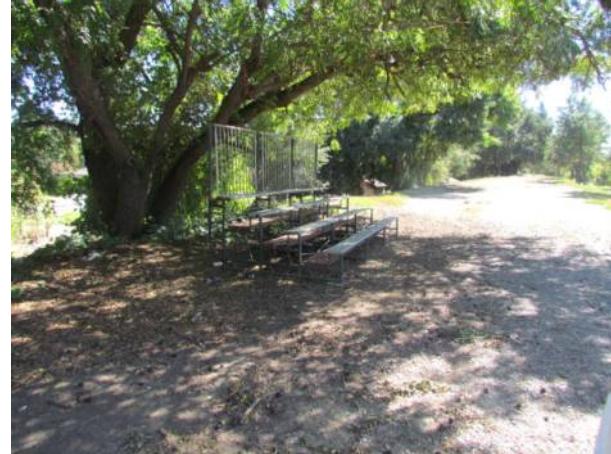
| richard_f_20130930_504.JPG | |

| Looking northeast at bleacher stored on landward shoulder. | |

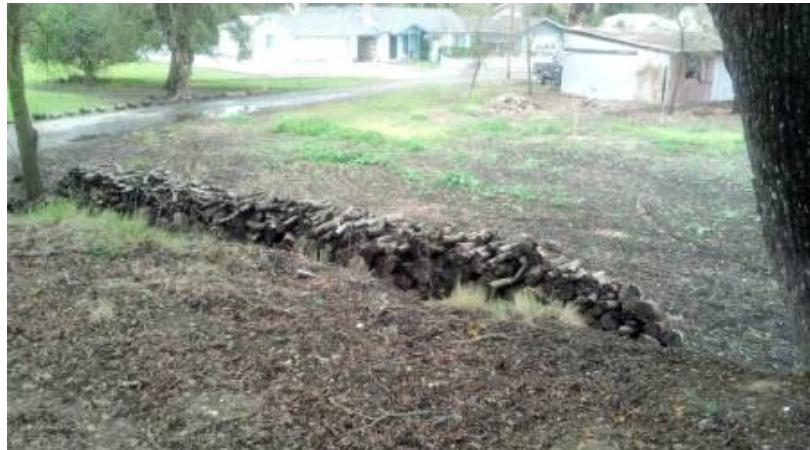
| richard_f_20130918_431.jpg | |

| Looking north at firewood piled at landside toe. | |
